STUDIES OF NOBLE-METAL THERMOCOUPLE STABILITY AT HIGH TEMPERATURES

P. D. Freeze and D. B. Thomas

Prepared for
NATIONAL AERONAUTICS AND SPACE ADMINISTRATION

Issued July, 1976

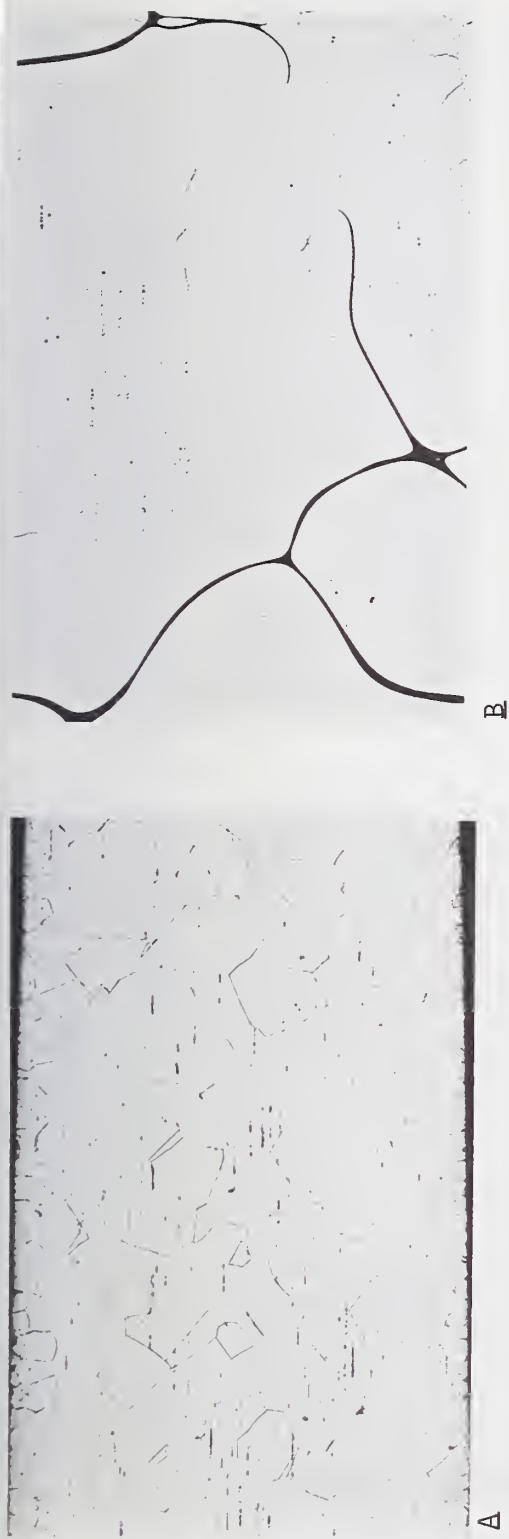
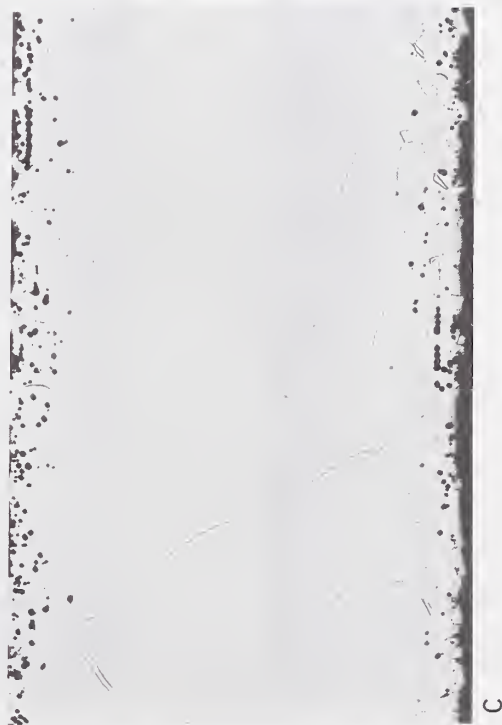
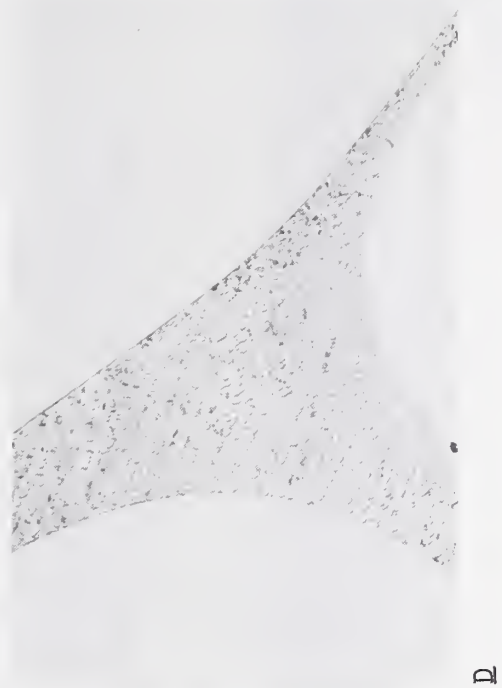
FIGURE 8: MICROGRAPHS OF SECTIONED IRIIDIUM-40% RHODIUM COMPONENT OF A TEST THERMOCOUPLE AGED AT 1700°C FOR 359 HOURS. PHOTOGRAPHS A, B, AND C WERE TAKEN WITH A MAGNIFICATION OF 100X; D, AN ENLARGEMENT OF A GRAIN-BOUNDARY PHASE FROM B, AT 1200X. FURTHER DESCRIPTION IS IN THE TEXT, 2.7.2. THERMOCOUPLE SYSTEM: IRIIDIUM-40% RHODIUM VERSUS IRIIDIUM.

Figure 8 presents micrographs of the sectioned iridium-40% rhodium component of the test thermocouple. Photographs a, b, and c were taken with a magnification of 100X; d, at 1200X. The changes in structure appear greater than those experienced by the other components in either atmosphere and suggest the possibility that this alloy may have experienced a change in composition as well as structural deterioration. Photograph 8a shows a longitudinal section of the alloy wire microstructure in regions not exposed to any high temperature, for reference. Photograph 8b shows a longitudinal section of the alloy wire that was exposed to high temperatures in an air atmosphere. The microstructure reveals a grain-boundary phase and large, smooth-cornered grains, whose presence indicates that melting had occurred. Photograph 8c is a longitudinal section of the same wire about 2.4 cm from the thermocouple junction showing erosion of the surface and voids near the surface. Considerable grain growth is also shown. Photograph 8d is an enlargement of the grain-boundary phase in 8b.

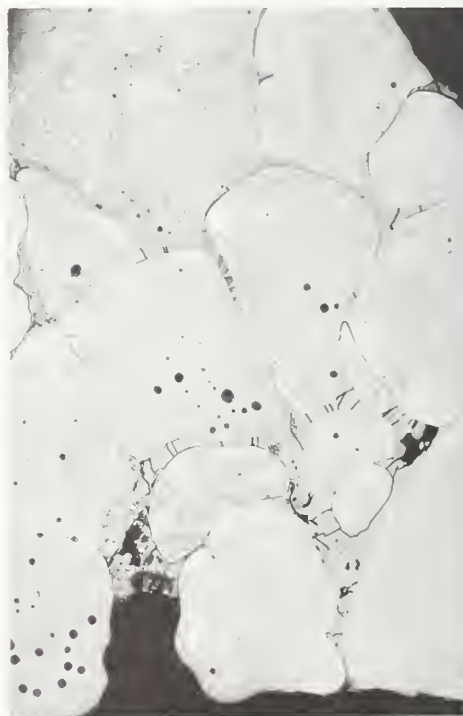
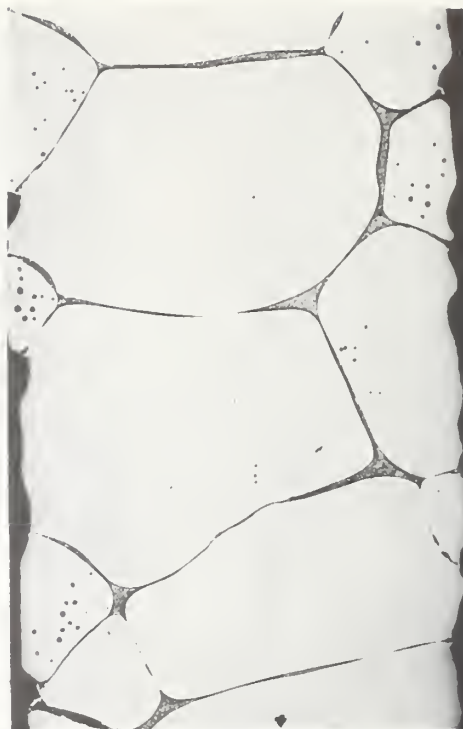
FIGURE 9: MICROGRAPHS OF SECTIONED COMPONENTS OF TEST (B, IRIIDIUM AND D ALLOY) AND REFERENCE (A, IRIIDIUM AND C, ALLOY) THERMOCOUPLES AGED AT 1850°C FOR 28 HOURS. THE MAGNIFICATION WAS 80X. FURTHER DESCRIPTION IS IN THE TEXT, 2.7.2. THERMOCOUPLE SYSTEM: IRIIDIUM-40% RHODIUM VERSUS IRIIDIUM.

Figure 9 consists of four micrographs at a magnification of 80X of specimens that experienced some structural deterioration. These specimens are longitudinal sections, and the widths of the polished surfaces shown in the figures do not necessarily correspond to the product of the wire diameter and the magnification. Following exposure to high temperature, some specimens were found to be considerably deformed and enlarged, especially near the tip. Figure 9a is a photograph of an iridium specimen taken from a reference thermocouple aged for 88 hours at 1850°C in nitrogen; photograph 9b is of an iridium specimen taken from a test thermocouple aged for 88 hours at 1850°C in air; photograph 9c is of an alloy specimen from the reference thermocouple; and photograph 9d is of an alloy specimen from the test thermocouple. The wire diameter was 0.81 mm. Photograph 9a shows a very large grain size, which indicates that grain growth had occurred. A slight surface erosion of metal is evident near the tip of the sample, at the right. These factors could have contributed to a structural weakening of the wire. Photograph 9b shows larger grains at the tip than at the shank. Some surface erosion is also in evidence. Photograph 9c shows erosion of metal at the surface. This photograph also shows a grain-boundary second phase and fine precipitate throughout the structure. It is probable that the grain-boundary phase was a liquid contaminant or an oxygen-deficient oxide at the test temperature, and that the precipitate in the grains was a sub-oxide precipitated during cooling. This is suggested by the rounded appearance of the grain-boundary corners. The lighter coloration of the oxide phase indicates a lack of oxygen.

Photograph 9d shows considerable surface erosion, a second phase at the grain boundaries, and fine precipitate throughout the structure. It seems probable from the coloration of the oxide phase that the oxide liquid was less oxygen-deficient than that for the specimen shown in 9c.

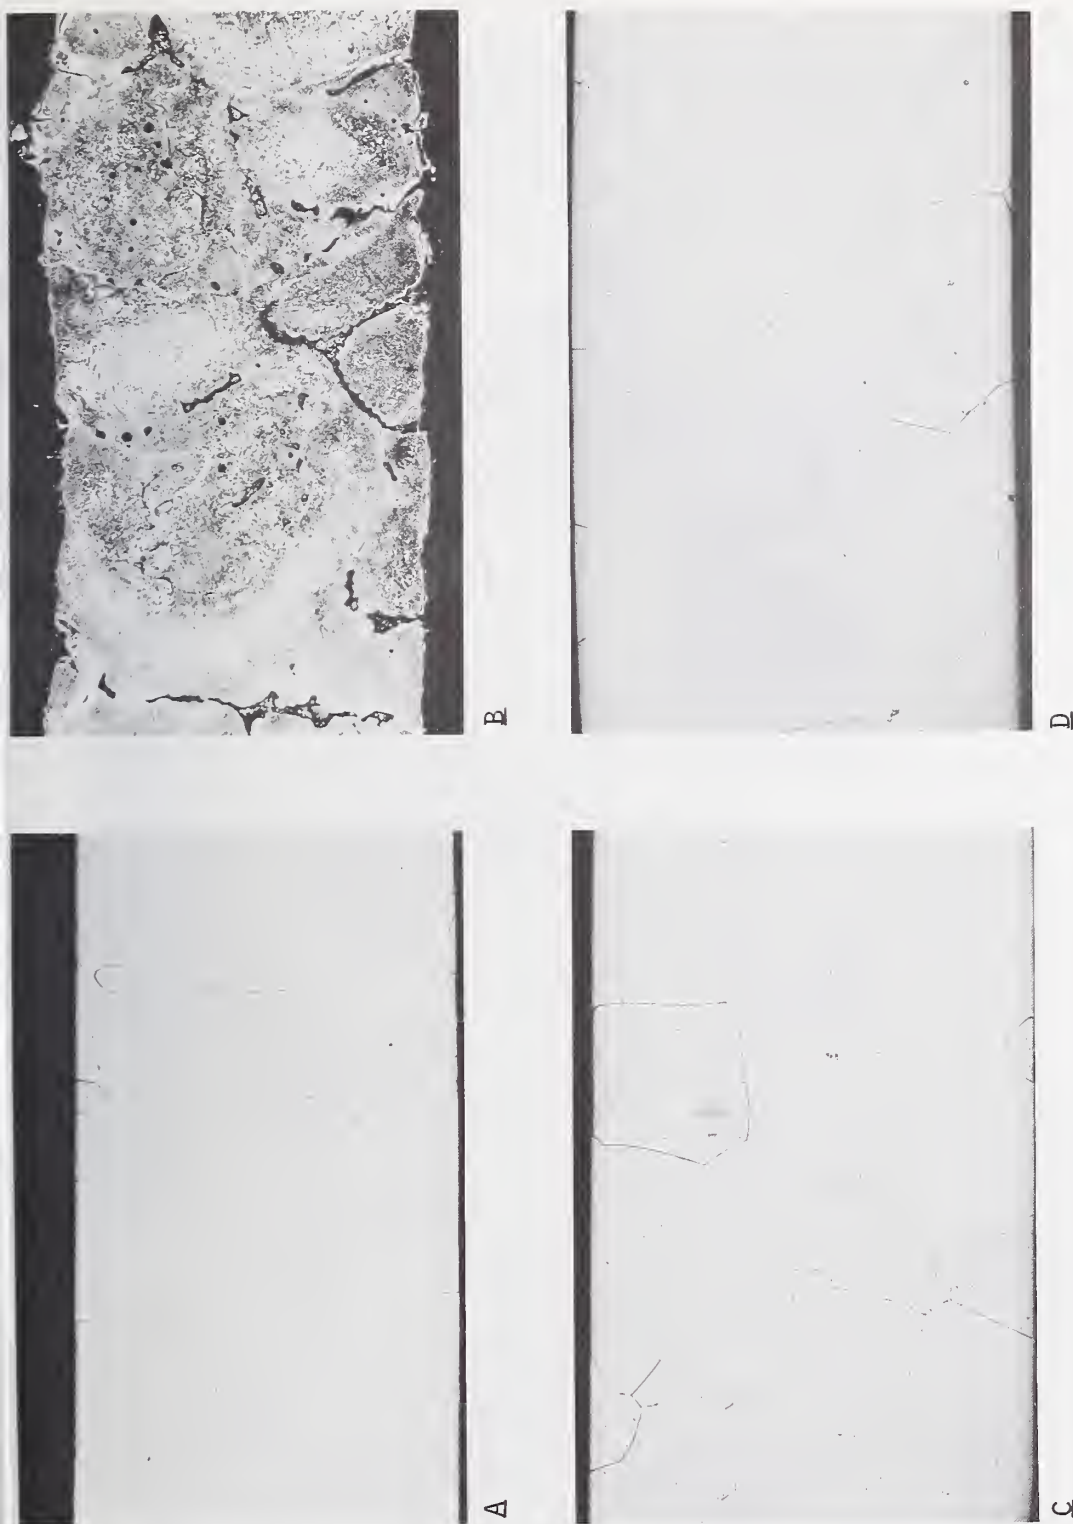
FIGURE 10: MICROGRAPHS OF SECTIONED COMPONENTS OF TEST THERMOCOUPLES UNHEATED (A, ALLOY AND C, IRIIDIUM) AND AGED AT 2000°C FOR 8 HOURS (B, ALLOY AND D, IRIIDIUM). THE MAGNIFICATION WAS 80X. FURTHER DESCRIPTION IS IN THE TEXT, 2.7.2. THERMOCOUPLE SYSTEM: IRIIDIUM-40% RHODIUM VERSUS IRIIDIUM.

Figure 10 consists of four micrographs at a magnification of 80X and illustrates changes in microstructure that may occur following exposure to a high-temperature oxidizing environment. Photograph 10a is of a specimen taken from an unheated portion of a thermocouple alloy component; photograph 10b is of a specimen taken from the same thermocouple component, but from a portion exposed to 2000°C, in air. Similarly, photograph 10c is of a specimen taken from an unheated portion of the iridium component of the same thermocouple, and photograph 10d is of a specimen taken from a portion of the same iridium component exposed to 2000°C, in air. The aged specimens were

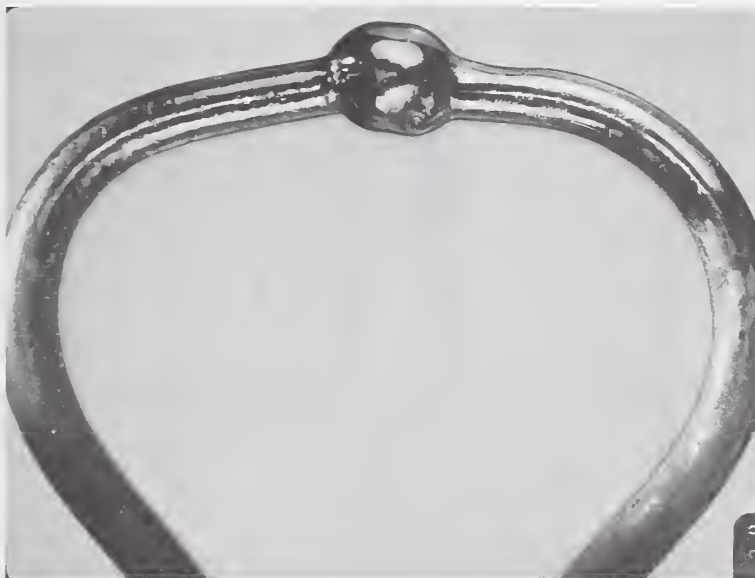
FIGURE 16: PHOTOGRAPHS AT MAGNIFICATION OF 15X OF WEDGE-CONFIGURATION (A) AND STIRRUP-CONFIGURATION (B) THERMOCOUPLES USED AT 1500°C AND AT A GRADIENT OF $1475^{\circ}\text{C}/\text{cm}$. THE PHOTOGRAPHS ARE DISCUSSED IN THE TEXT, 3.7.2. THERMOCOUPLE SYSTEM: PLATINUM-13% RHODIUM VERSUS PLATINUM.

3.7.2 Surface, Microstructural, and Chemical Studies — Figure 16 presents photographs at a magnification of 15X of the two thermocouples of figure 14.

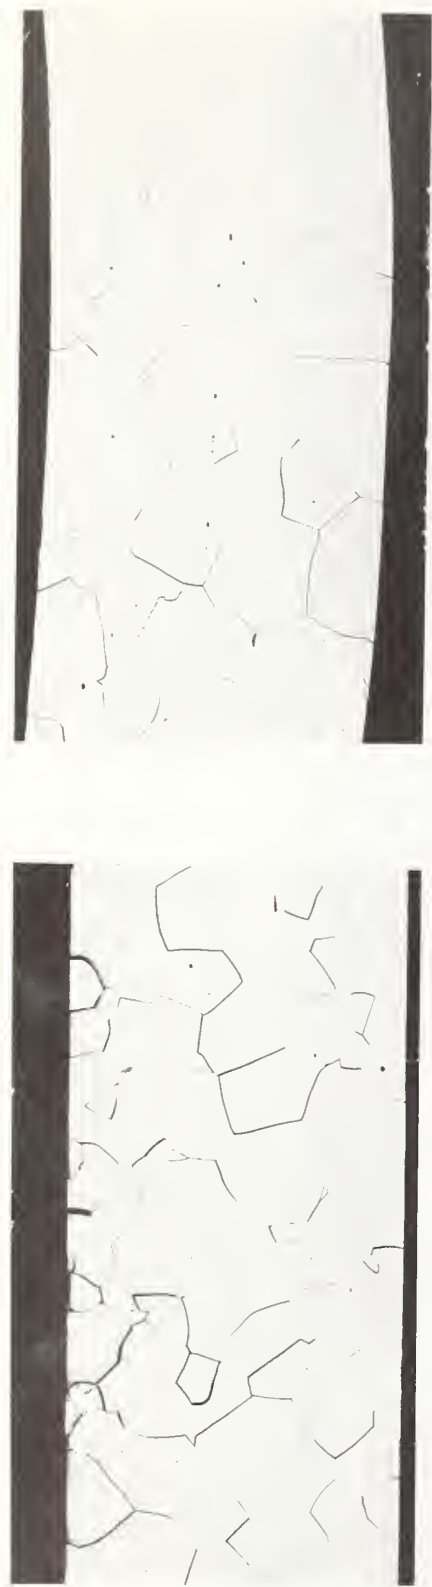
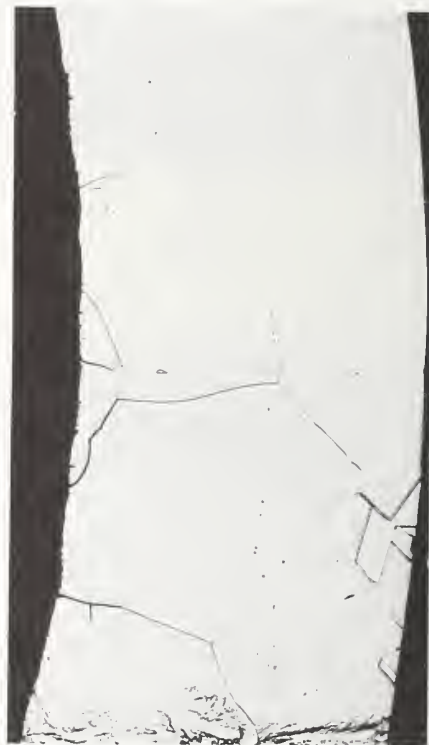
FIGURE 17: MICROGRAPHS OF SECTIONED ALLOY COMPONENT OF A TEST THERMOCOUPLE AGED AT 1500°C AND AT A GRADIENT OF 1475°C/CM FOR 60 HOURS. WIRE DIAMETER WAS 0.51 MM; THE MAGNIFICATION WAS 90X. PHOTOGRAPH A SHOWS A SECTION TAKEN 1.0 CM FROM THE JUNCTION; B, 0.5 CM FROM THE JUNCTION; AND C, 0.05 CM FROM THE JUNCTION. FURTHER DESCRIPTION IS IN THE TEXT, 3.7.2. THERMOCOUPLE SYSTEM: PLATINUM-13% RHODIUM VERSUS PLATINUM.

Figures 17 and 18 present micrographs (at 90X) of specimens taken from the alloy component (figure 17) and the platinum component (figure 18) of a platinum-13% rhodium versus platinum thermocouple exposed to a junction temperature of 1500°C and a gradient of 1475°C/cm. Wire diameter was 0.51 mm. The exposure time before failure was 60 hours. The emf values of this thermocouple are given in table 6. In each figure, photograph a shows a section taken 1.0 cm from the junction; b, 0.5 cm from the junction; and c, 0.05 cm from the junction. The temperatures at these points along the wires may be estimated to be 25, 760, and 1425°C, respectively, assuming a somewhat linear gradient. The photographs of the specimens closest to the junction show marked grain growth compared to the grain size in cooler areas. There is no evidence of severe surface erosion.
